# PIANC WORKSHOP

## 'MITRE GATE DESIGN and OPERATION'

*In the framework of  
the PIANC InCom Report n°154*

The workshop on 6<sup>th</sup> Nov. is a one day event to launch and promote the new PIANC Report n°154 on **Mitre Gate Design and Operation** (published by PIANC in August 2017).

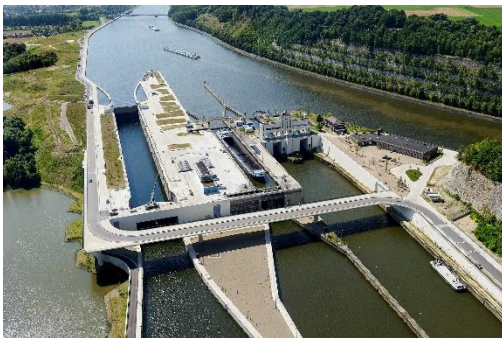
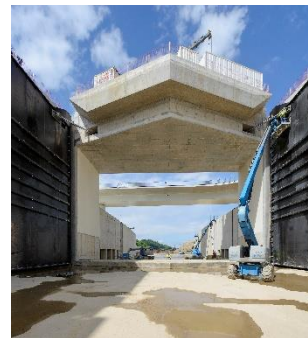
The new class Vlb lock of Lanaye (225mx25m) is equipped with a downstream mitre gate. The lock water head is 14 m. The lock was inaugurated in July 2015.

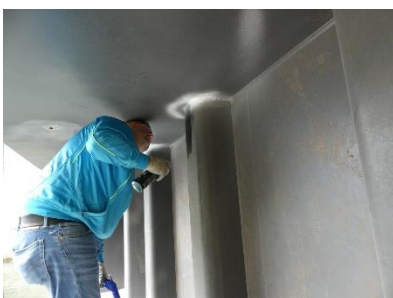
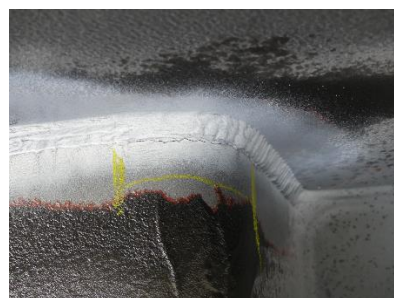
One year later, a series of cracks were detected along the vertical stiffeners of both leaves of the miter gates.

The technical explanation was found out a few weeks later: the filling and emptying cycles of the lock generate a repeated local distortion of the horizontal box girders, whose webs are directly connected to the vertical stiffeners (U-rib). Local bending stresses appear and lead to fatigue cracking (oligo-cyclic phenomenon).

A close collaboration started straight away between all the involved services (Public Administration, Contractors, Study Office, Supervising Office and Insurance). A series of investigations and additional calculations were performed (residual stresses due to welding method, combination of bending and shearing effects in the stiffeners, fatigue induced cracking,...).

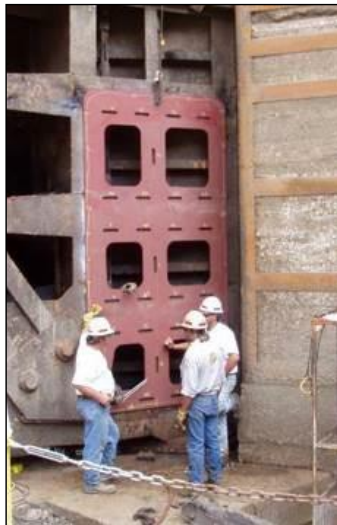
In the USA, there has been widespread problems with miter gates cracking near the pintle (bottom pivot) of the gate. The main cause is lack of bearing contact of the gate-to-wall contact blocks. When contact is lost, the large hydrostatic forces acting on the gate are transferred horizontally along the gate through the main framing beams into the pintle (pivot) instead of into the wall bearing area. This causes large localized stresses in the pintle region which when coupled with poor material fracture toughness and poor geometrical detailing leads to cracks.

In 1998, cracks were discovered in the skin plates and bottom girders of both gate leaves at the Lower Granite Lock on the Snake River in the state of Washington (See figs on the right). A variety of repair techniques were used to get the gate back into operation.

In 2004, in the McAlpine Lock on the Ohio River cracks were found, which lead to emergency repairs and temporary lock closure. The lock gates were repaired using large patch plates (See Fig bottom left).

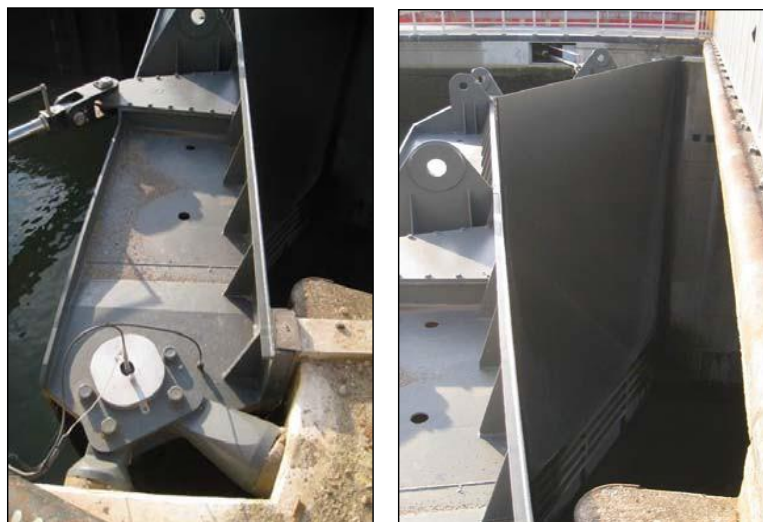
The Maasbracht Locks (Sluizencomplex Maasbracht) located on the Juliana Canal in the Netherlands. A variety of interesting issues will be discussed including hinge design using FRP, anchorage failure, fatigue design of welded connections, and contact blocks using FRP.
